Case study

Implementing a small weir removal – with infrastructure constraints

Lambrigg beck, Cumbria

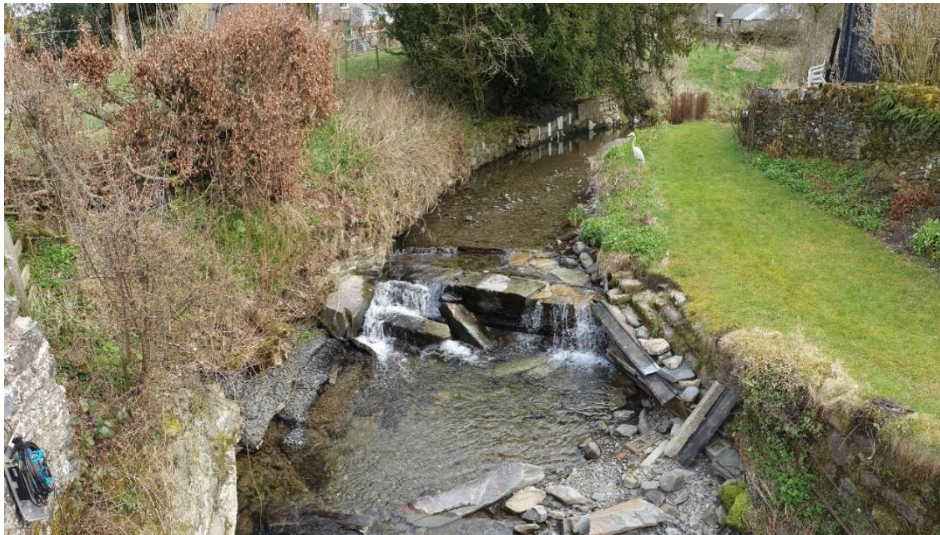
The small weir prior to removal. A large scour hole had formed immediately downstream of the weir.

- A small plunge pool has developed downstream of the weir as a result, which has destabilised the banks and is undercutting the right bank masonry wall.

- General bed lowering has occurred downstream which has impacted on the bridge with the bridge abutments now exposed, some of which are 0.3m above present bed level.

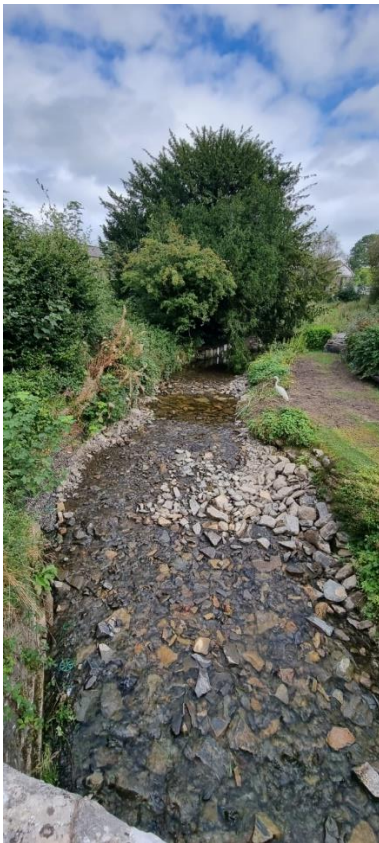
L: New regraded channel with the weir removed

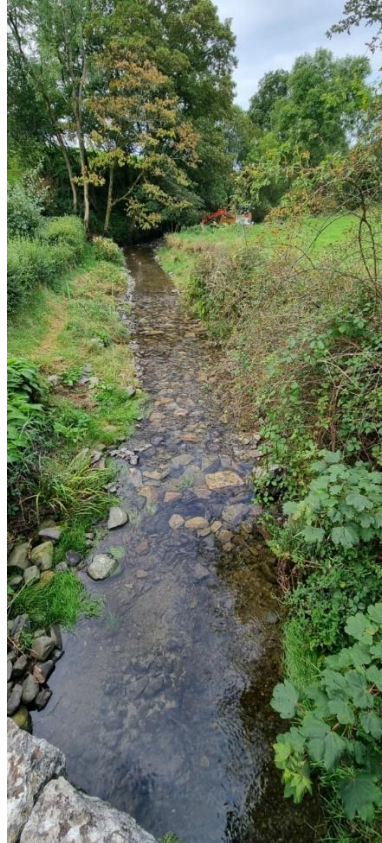
R: Downstream section bed raised to aid flows underneath the bridge

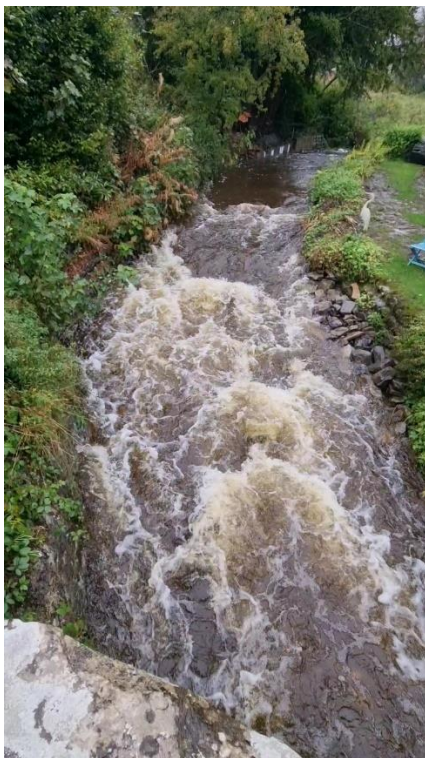
L: Weir removal site during high flows (taken October 2022)

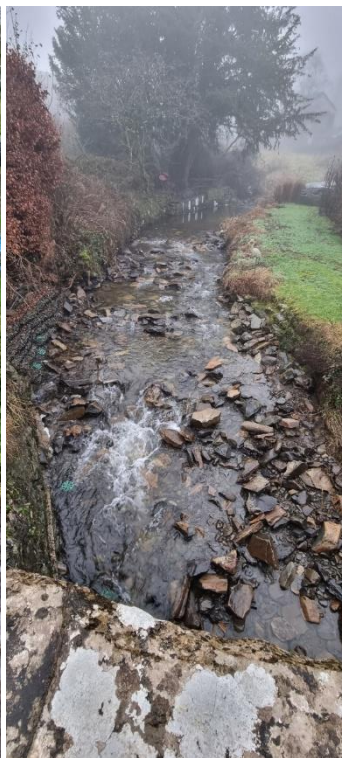
R: Post weir removal in January 2023, the water pipe has become exposed as a result of high flows during the winter months.

- Further work was required at the site as the water pipe has become exposed. Following high water levels and flood events in winter of 2022, and early into 2023, the water pipe became exposed, leading to further works required at the site.
- An assessment of boulders that didn't move was determined at 550mm, in which these size rocks will be used to cover the water pipe.
- The further works began on the 4th September 2023, by IT Shaw, crayfish relocation surveys were completed each day prior to the works starting.
- Future electrofishing post works to be completed to determine the effectiveness of the weir removal.
- Post restoration River Habitat Survey.

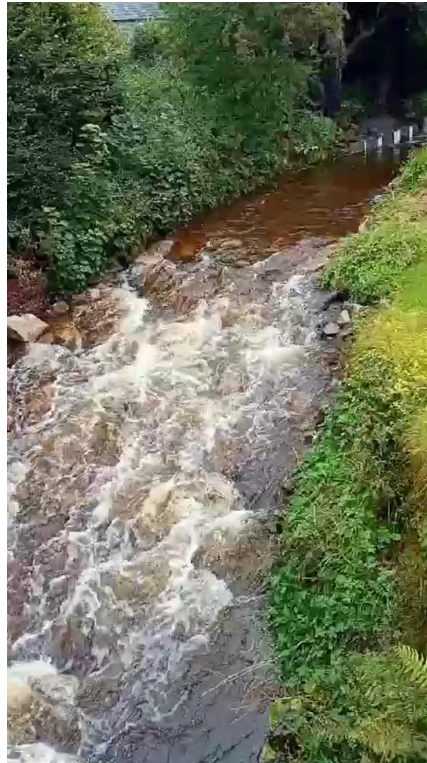
R: Revised works now holding well during high flows
